DIVISION Power Systems  
TM 7972:70-640  
DATE 25 August 1970  
W.O. 1475-78-2000

**TECHNICAL MEMORANDUM**

TITLE: Evaluation of SNAP 8 Bare Refractory Double Containment Boiler No. 2  
After 8700 Hours of Operation

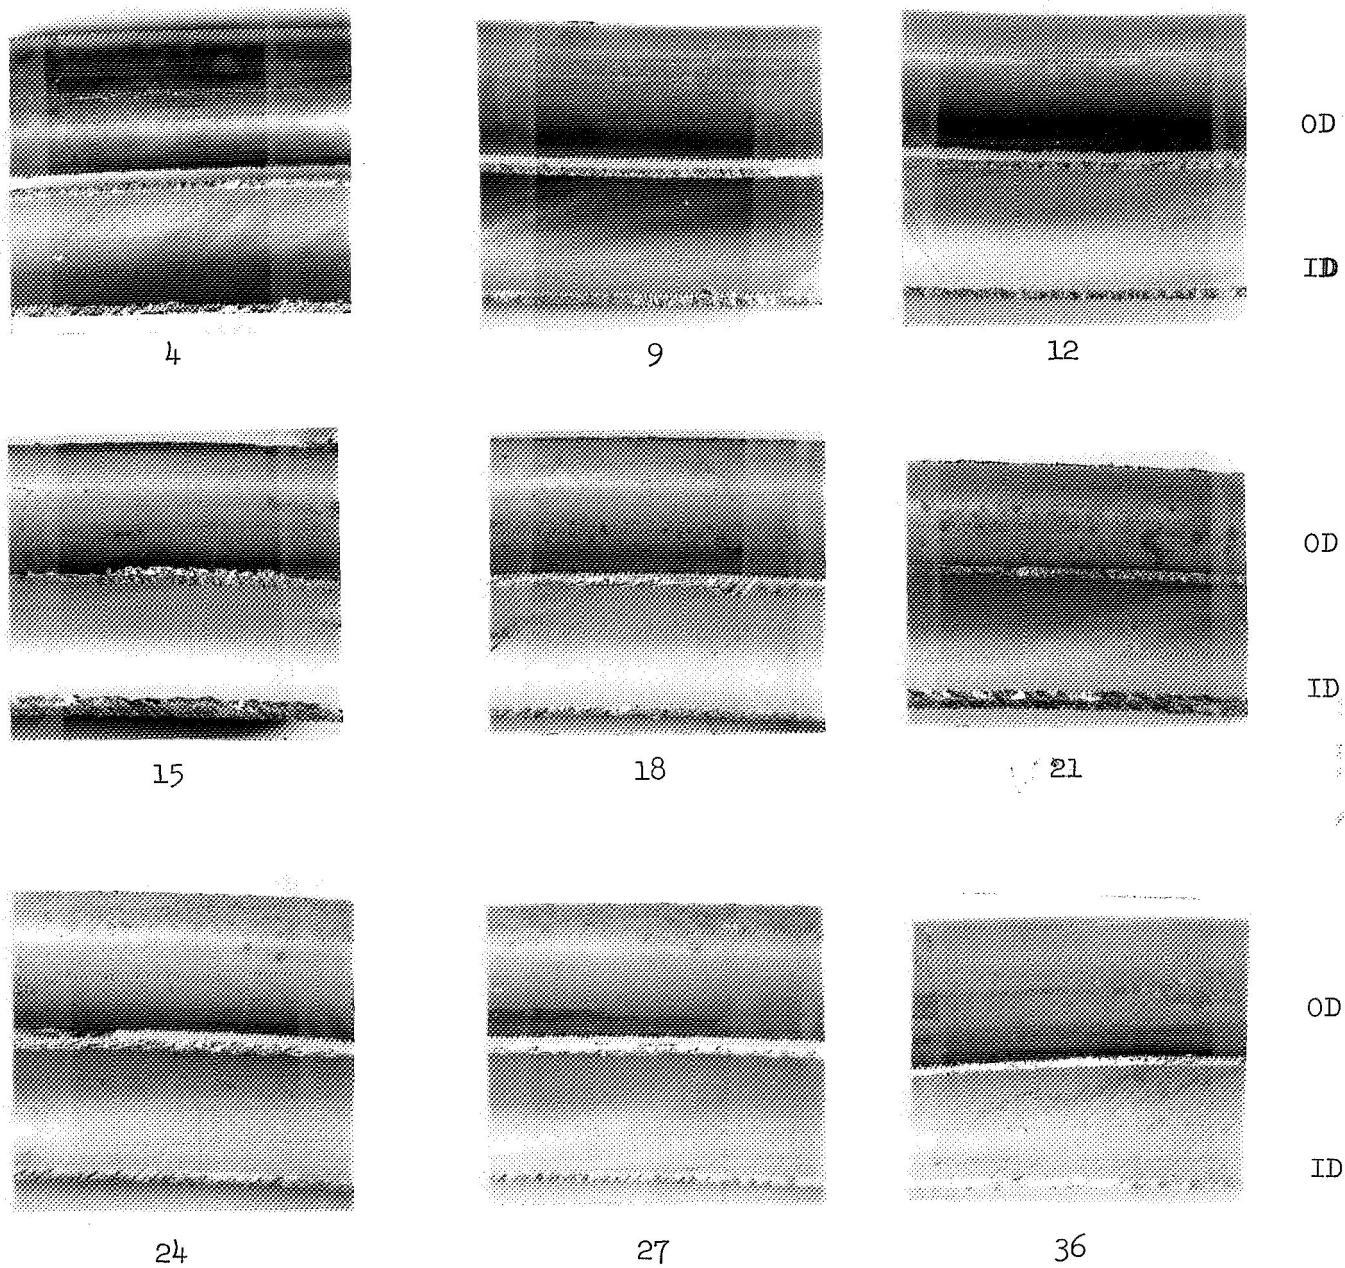
Visual examination of the O.D. of the Ta tube which had been exposed to the static NaK during boiler operation and subsequently the decontaminating solutions after removal from the PCS-1 system, revealed the presence of a black surface at the NaK outlet, Figure 1. This coloration gradually faded, and from approximately twelve feet from the NaK outlet to the NaK inlet the tube was spottily discolored in a manner indicating probable contact with the 321SS static NaK containment tube. Except for the localized wall thinning of the Ta tube under the crack in the static NaK tube, no visual evidence of corrosion of the Ta tube was detected. However, some scoring of the Ta tube O.D. was present, Figure 2, presumably due to contact with the static NaK containment tube and relative movement between the two tubes due to differential thermal expansion

Figure 1 - Appearance of I.D. and O.D. of Ta tube at various distances in feet from the Hg inlet. Approximately full size.

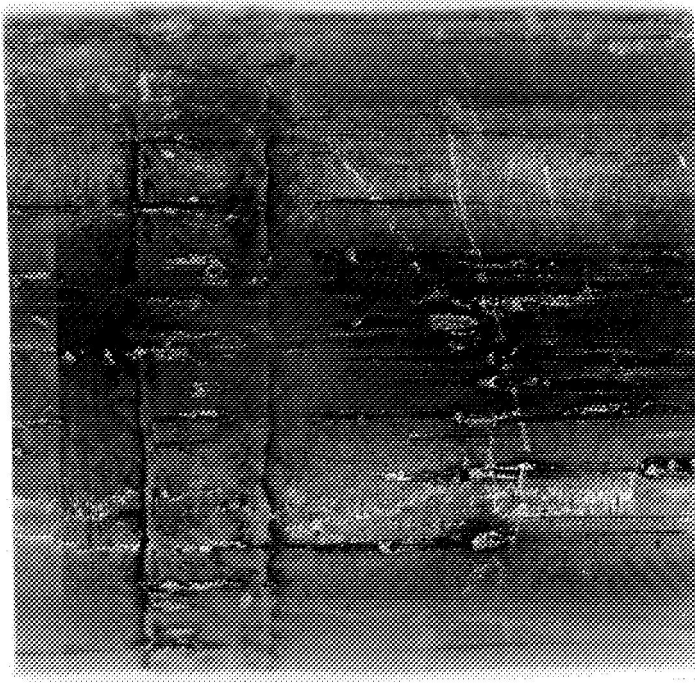
17. Scoring of the O.D. of the Ta tube was the result of its rubbing against the 321SS static NaK containment tube during thermal cycling caused by the difference in thermal expansion coefficients of the two materials. The maximum depth of affected Ta was 0.003 inches and the defects did not tend to propagate from the tube wall into the tube.

Metallographic examination of the Ta tube at the end of the straight section where the most severe scoring was visually observed, indicated that the scoring extended below the original tube contour to a maximum of approximately 0.0008 inches. However, the cold flow of the Ta had caused rises at the edges of the scores up to approximately 0.0022 inches. This made the scoring appear visually to be more severe than it was. There was no indication that the scoring caused any initiation of cracking of the tube wall. There was also material galled into the Ta, Figure 2. This presumably was 321SS from the static NaK containment tube since mass transfer products were not detected metallographically on the Ta tube O.D.

Figure 2 - Scoring and galling of O.D. of Ta tube at end of straight Hg inlet section. Left - general appearance, right - transverse cross-section through tube showing material galled into O.D.

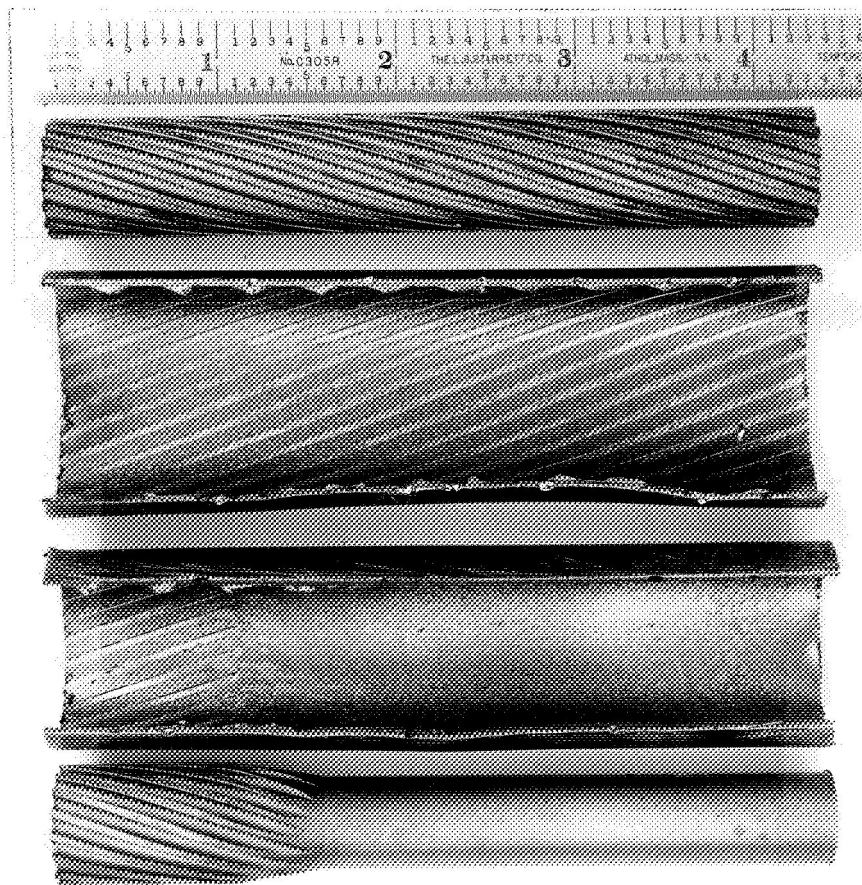
corrosion of the Ta was detected by metallographic examination of various sections from the Hg inlet to the outlet end of the boiler. In the plug section, the tube I.D. was expanded in the areas where it had been swaged over the lands of the plug, Figure 5. Intimate contact between the tube and the plug lands had been achieved by the swaging operation and maintained through the 8700 hours of operation of this boiler verifying the suitability of the inlet plug section fabrication procedure.

Figure 3 - Multipassage Ta plug and I.D. of Ta tube from Hg inlet of boiler.

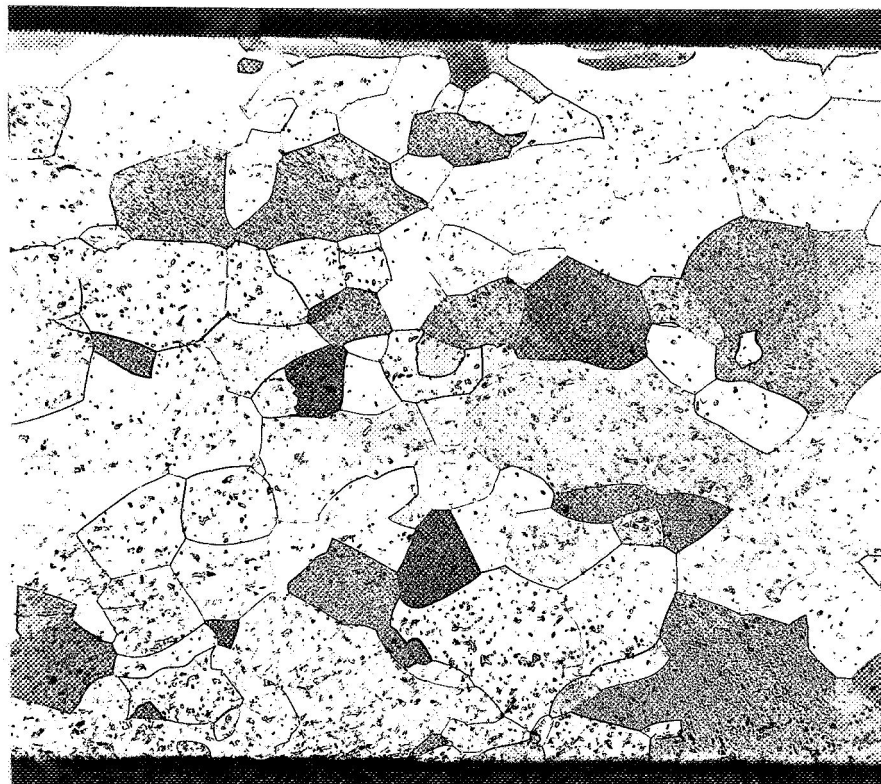
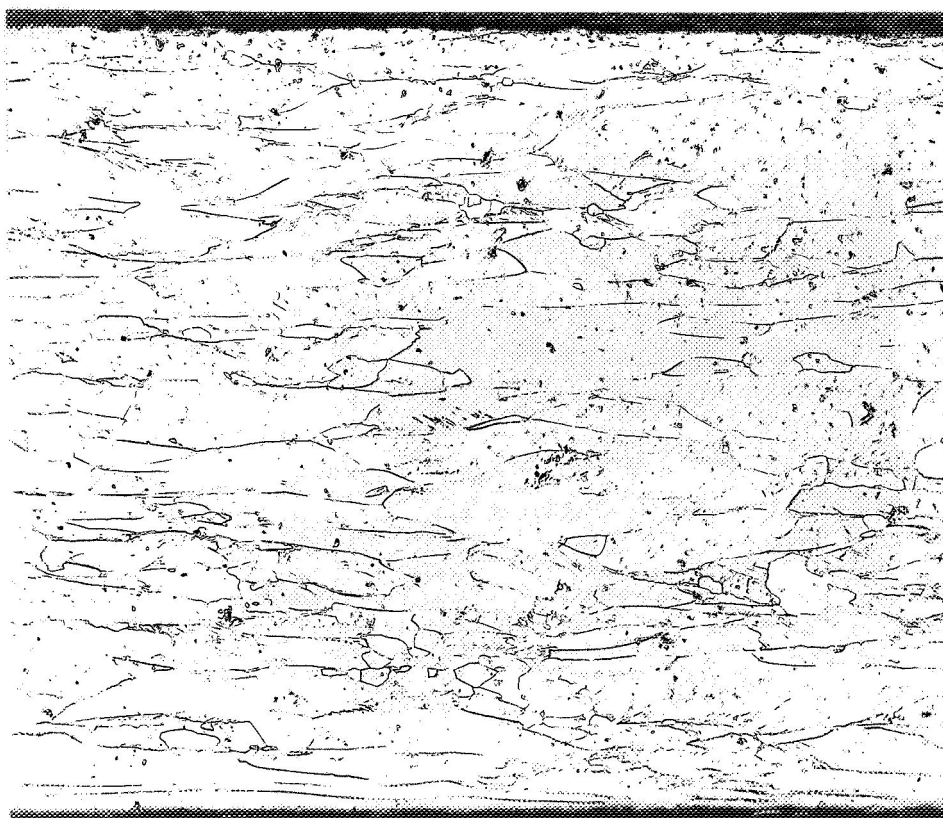
The metallographic examination revealed that Ta tubing in two different conditions was used in the fabrication of the boiler. The tubing in the straight inlet plug section and the last eight inches at the Hg outlet was recrystallized, but the tubing from the tube-to-tube weld at the end of the plug section to the tube-tube weld near the Hg outlet of the boiler was in the cold-worked condition, Figure 4. From the elongated grain structure produced by the cold-working, it was estimated that the Ta was cold-worked approximately fifty percent. The cold-working increased the hardness of the Ta tube as revealed by the microhardness traverses performed, Table II. The average Knoop hardness of the cold-worked material was 147 KHN (130-158 KHN range) and of the unswaged recrystallized tubing at the inlet was 108 KHN (102-113 KHN range). The only area of the parent metal tubing which exhibited a true hardness gradient was the inlet end where it had been swaged over the plug. The hardness in this area was as high as 296 KHN at the surface with an average cross sectional hardness of 151 KHN. This hardness gradient was produced by the cold-work introduced into the recrystallized Ta by the swaging operation. The cold-worked tubing comprising most of the length of the boiler tube did exhibit a variation in hardness across the wall thickness, but the pattern was not uniform and could not be interpreted as a through-wall gradient. In general, the O.D. did tend to be slightly harder than the I.D., but this was not true at all locations tested. In some areas, the center of the wall thickness was harder than either the I.D. or the O.D. If oxygen contamination of the Hg loop had occurred, a decreasing hardness gradient from the I.D. to the O.D. of the Ta tube wall would be anticipated. Therefore, it is presumed that the Ta wall hardness variation was due primarily to the previous cold-work history of the Ta tube. Cold-worked Ta exhibits lower ductility than recrystallized Ta; the ductility decreasing with increasing amounts of cold reduction. Although mechanical tests were not performed to determine actual values, the cold-worked Ta in this boiler would exhibit lower ductility than if it had been recrystallized. Therefore, an undetermined but shorter low cycle fatigue life would be anticipated. No indications of cyclic stress failure were detected in the boiler tube, but for optimum resistance to the low cycle fatigue failure, future boilers should be fabricated from recrystallized Ta. No evidence of Hg

Figure 4 - Longitudinal cross-sections through Ta tube. Recrystallized structure from Hg inlet straight section, top; and cold-worked structure 18 feet from Hg inlet 100X, Glyc + HF + HCl + HNO<sub>3</sub> etch.

5. Although no indications of initiation of failure of the Ta in the BRDC #2 boiler were detected, future boilers should be constructed of recrystallized rather than cold worked Ta to provide greater ductility of the material and to reduce the possibility of failure due to low cycle fatigue and hydrogen or oxygen embrittlement.

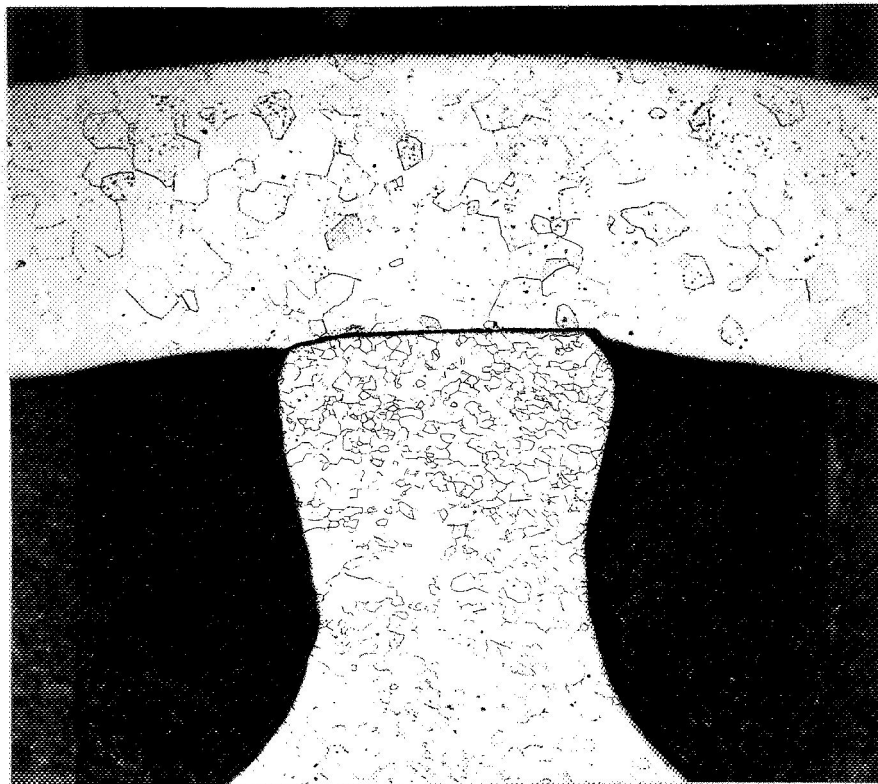
Figure 5 - Transverse section through Ta tube and plug at Hg inlet.

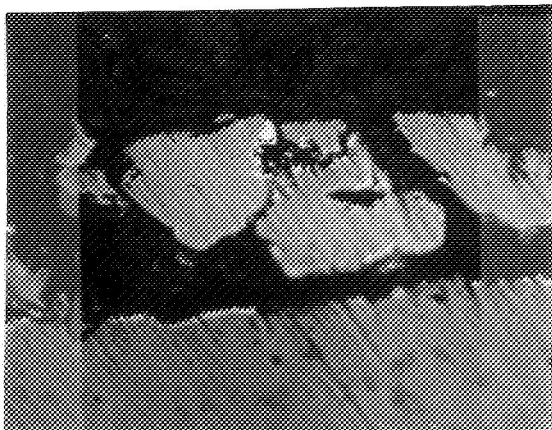
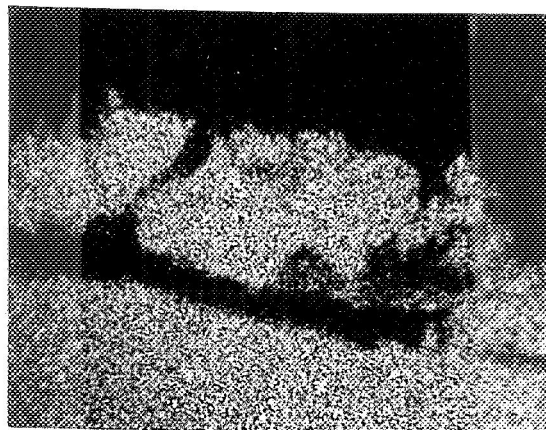
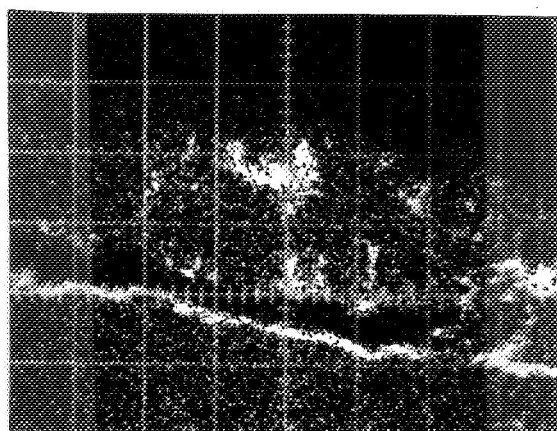
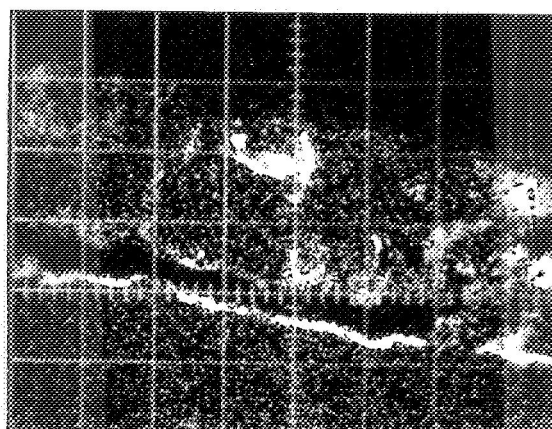
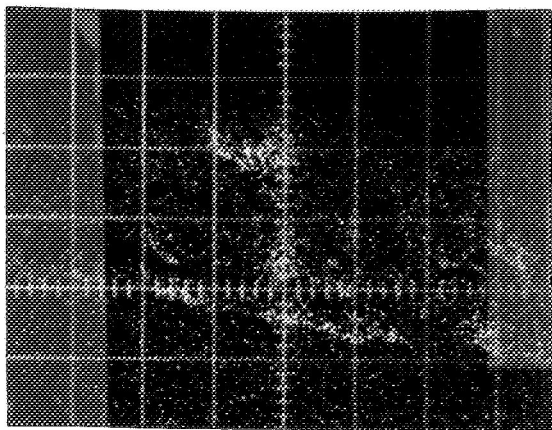
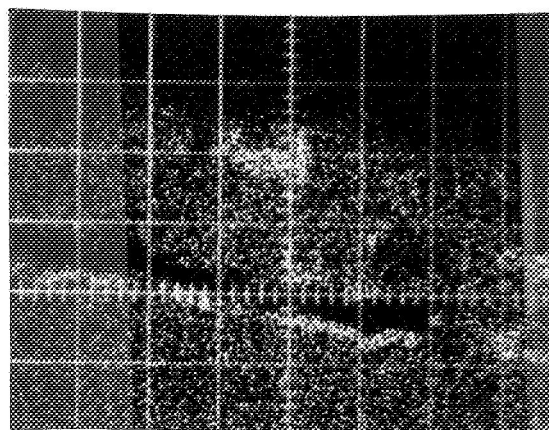
Figure 9 - Radiation displays of I.D. of Ta tube 15 feet from Hg inlet header showing distribution of Ta, Ni, Fe, Cr, and Co. 340X  
See Figure 10 for another display from another circumferential location on same tube cross-section.

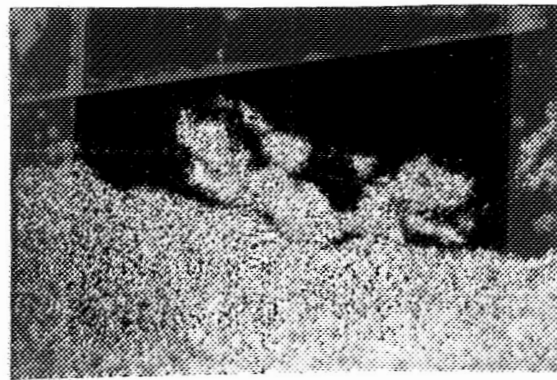
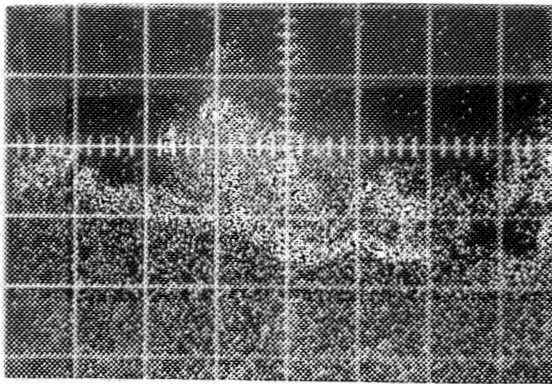
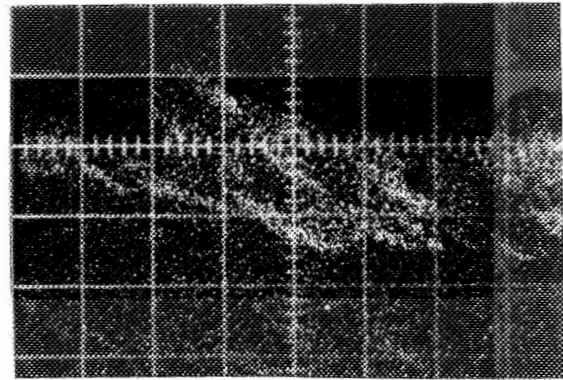
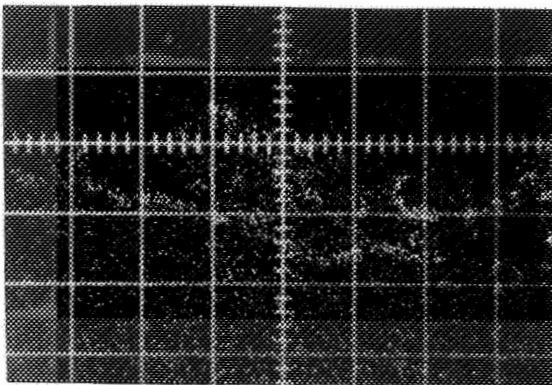
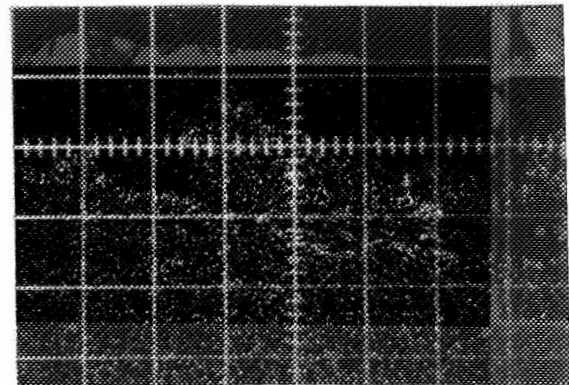
Figure 10 - Radiation displays of I.D. of Ta tube 15 feet from Hg inlet header showing distribution of Ta, Ni, Fe, Cr, and Co. 340X

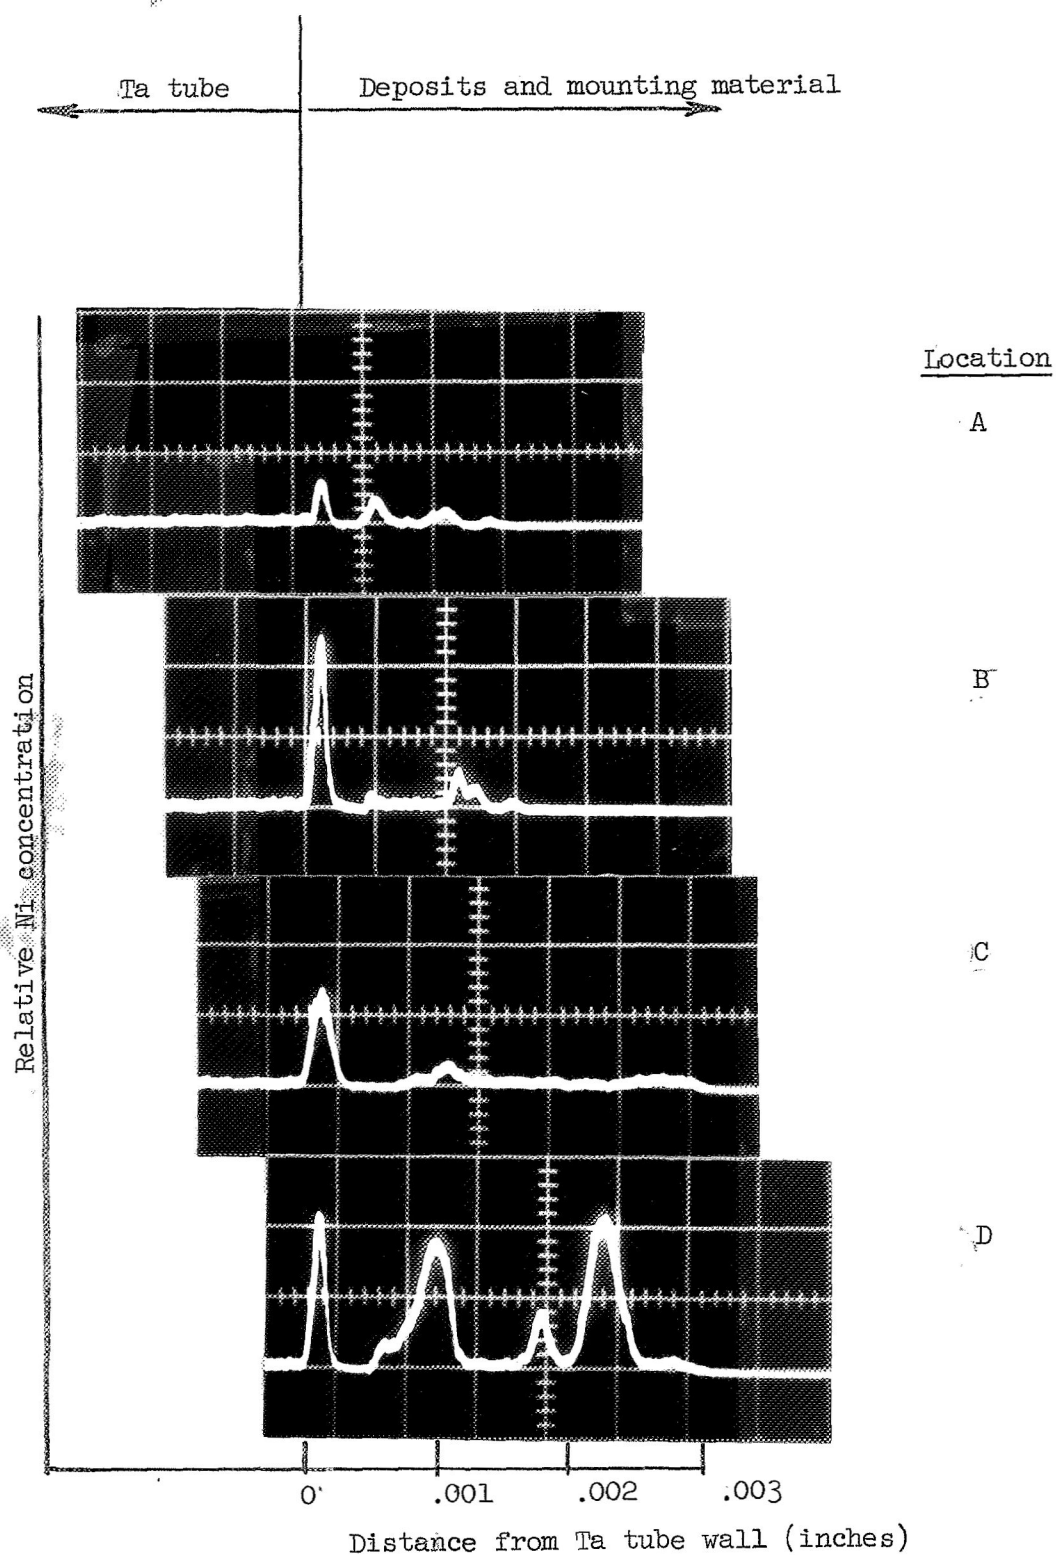
Figure 11 - Nickel concentration radiation traces at four random I.D. locations on cross-section of Ta tube 15 feet from Hg inlet.

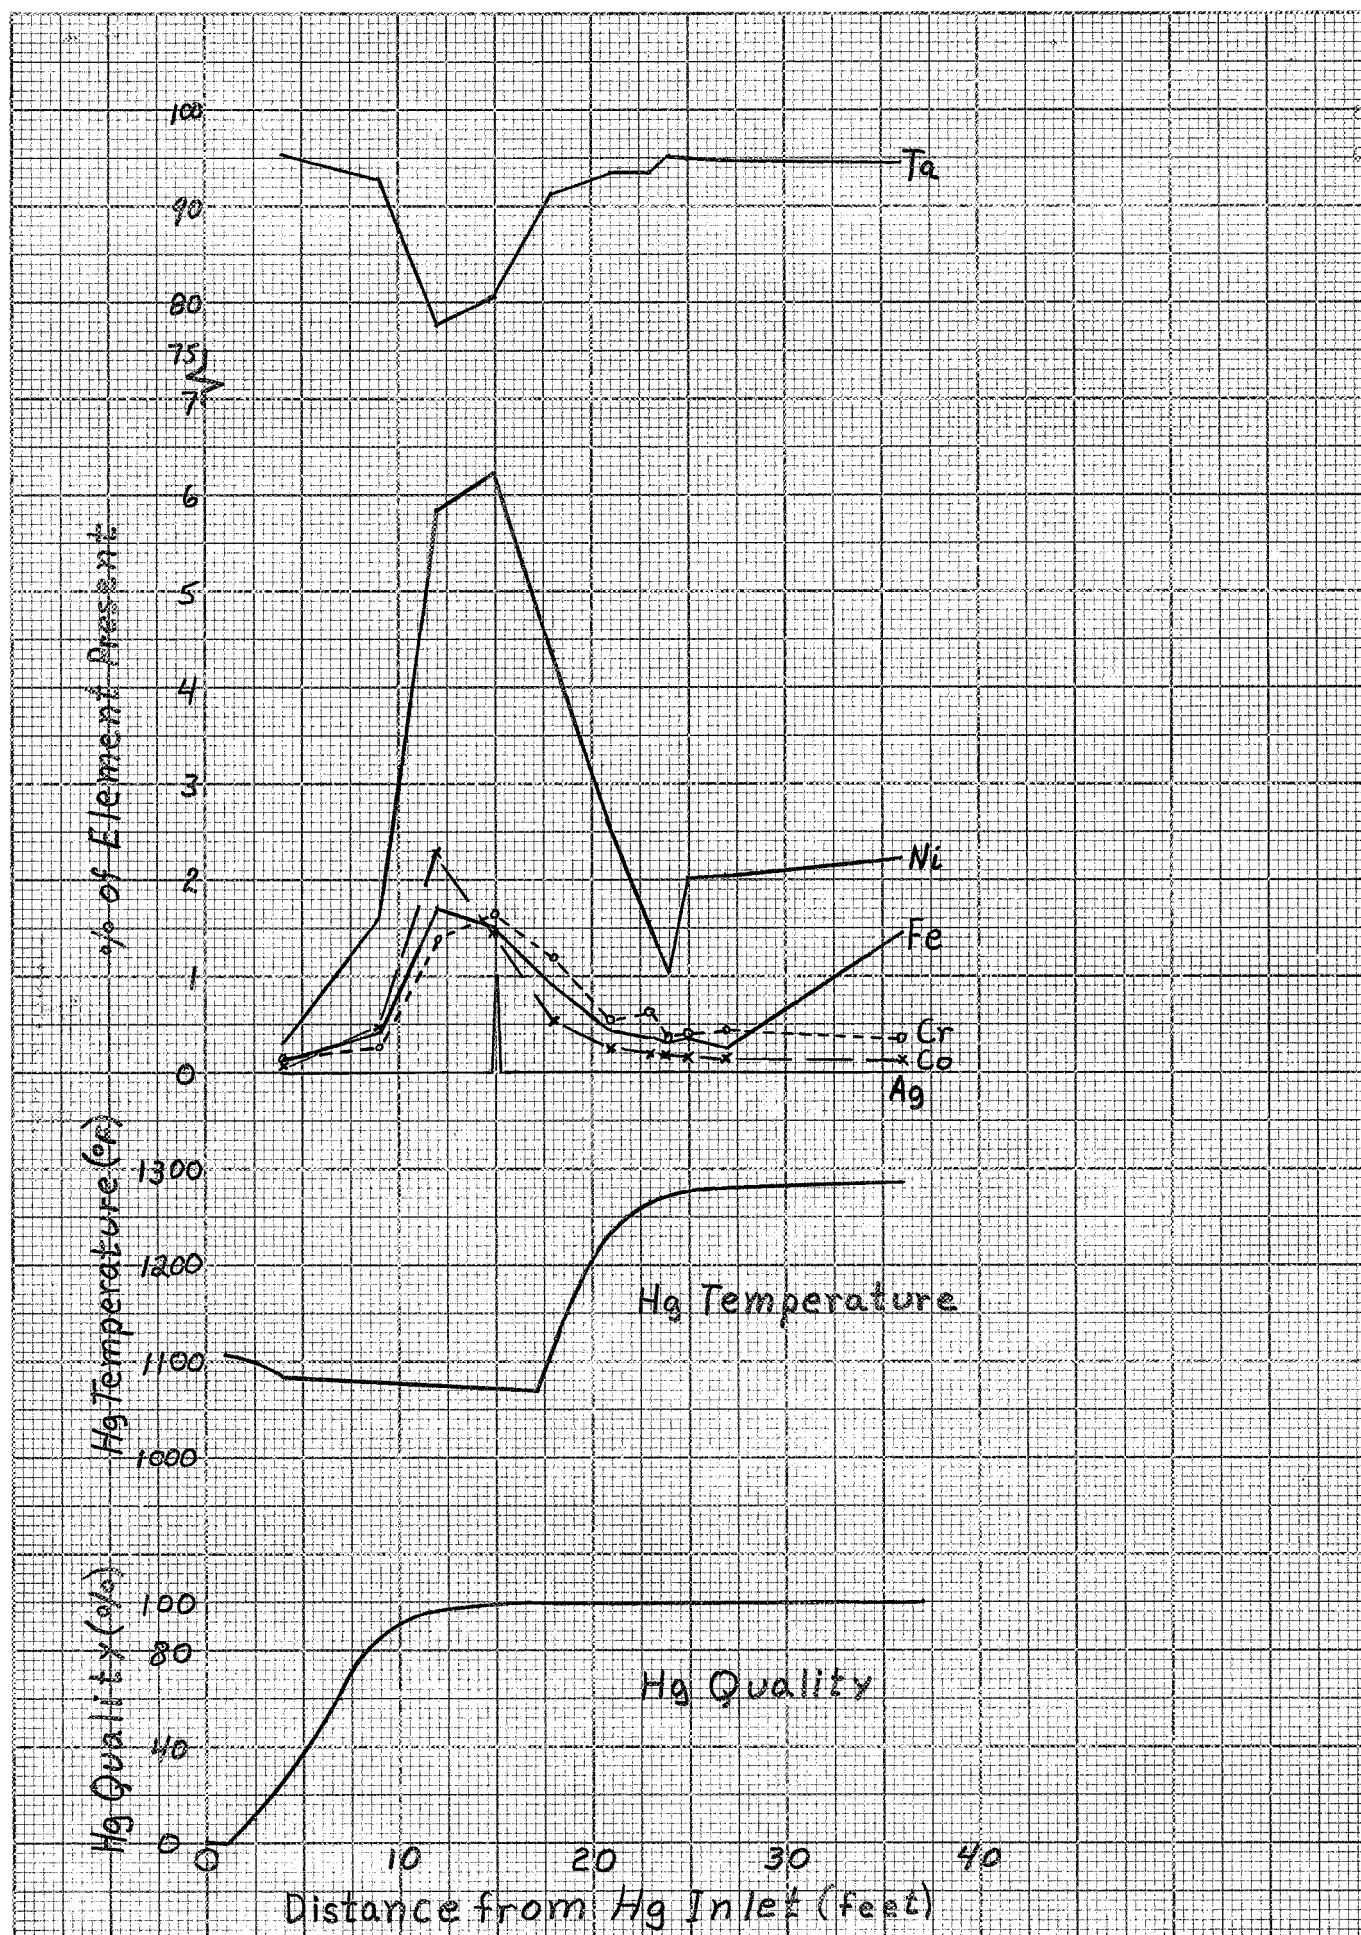
A pattern of mass transfer product deposition was present along the length of the Ta tube from the Hg inlet to the outlet. This was observed by a difference in the X-ray fluorescence analyses of flattened tube I.D. surfaces at various locations along the length of the tube, Figure 12. The fluorescence analyses indicated not only a difference in thickness of the deposits but also a change in composition at the various locations. These analyses correlate well with the condition of the Hg during boiler operation. In the plug region of the boiler where the cold incoming Hg was being heated and boiling initiated, no deposits were detected metallographically. By scraping the I.D. surface of the straight Hg inlet tube, and thus providing a concentrated sample the presence of small quantities of Fe, Ni, and C was established. As the quality of the Hg increased farther into the boiler, the amount of deposits present increased until

Fig.12.Composition of I.D. of Ta Tube as Determined By X-Ray Fluorecence Analysis.

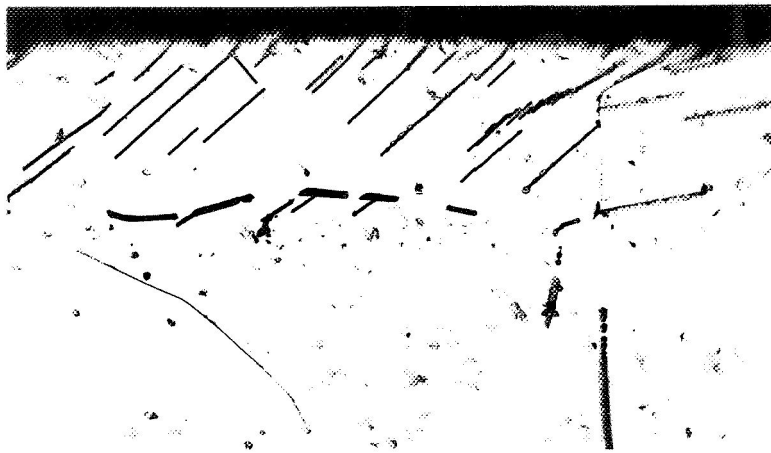
13. Oxidation of the O.D. of the Ta Hg inlet dome and header occurred during a boiler repair weld operation. During subsequent boiler operation the NaK leached the oxides from the Ta thus leaving voids. This same condition was present to a minor extent at one of the original Ta tube-tube welds. These defects did not propagate and had no adverse effect on the boiler operation.

Figure 13 - O.D. surface of Hg inlet Ta dome showing effect of static NaK removal of oxides produced in the weld heat affected zone during repair welding.

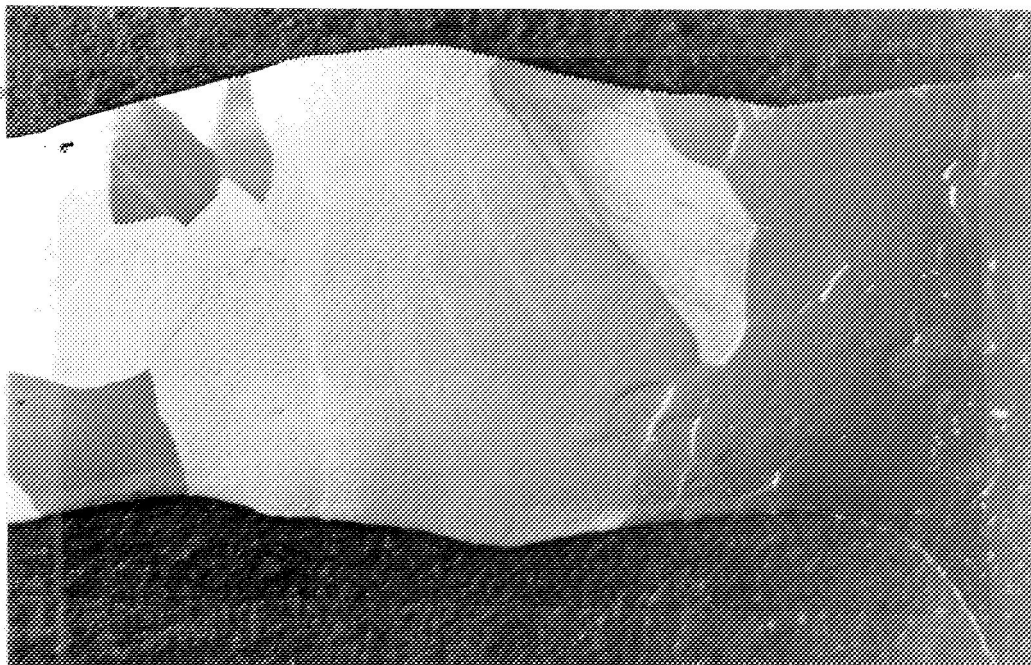
The Ta weld joining the header to the outlet dome was examined metallographically. Although a few minor inclusions were observed in the weld metal, the joint appeared to be excellent, Figure 16. The hardness in the heat affected zone and the parent metal was somewhat erratic but showed no gradient across the wall thickness from O.D. to I.D., Tables V and VI. This is the same condition which existed at the inlet dome except the hardness level of the outlet is lower.

Figure 16 - Weld of Ta dome to header at Hg outlet.

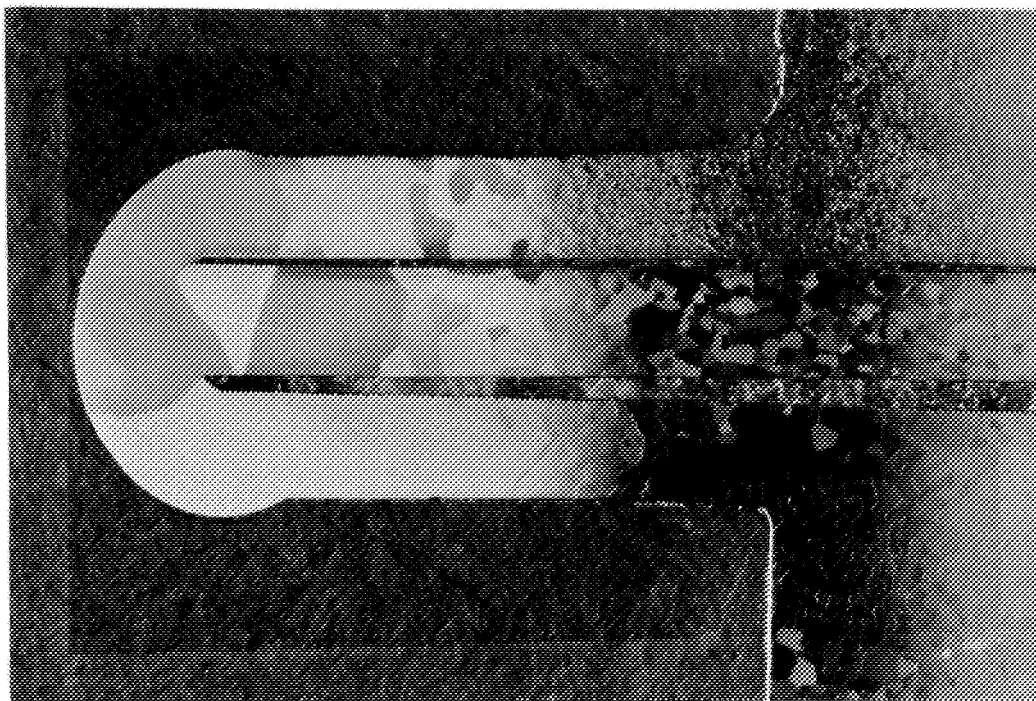
A section of the Ta tube-header-orifice weld at the Hg inlet was examined metallographically, Figure 17. No defects were detected; however, the wall thickness of the tube in the weld metal consisted of only one grain. The hardness of this weld averaged 130 KHN with the Hg exposed surface being 129 KHN and the core being as high as 140 KHN. This is the same condition that existed at the outlet tube to header weld except at the inlet header the hardnesses were somewhat higher. No indications of corrosion, erosion or mass transfer product deposition were detected metallographically.

Figure 17 - Ta Tube/Orifice/Header weld at Hg inlet

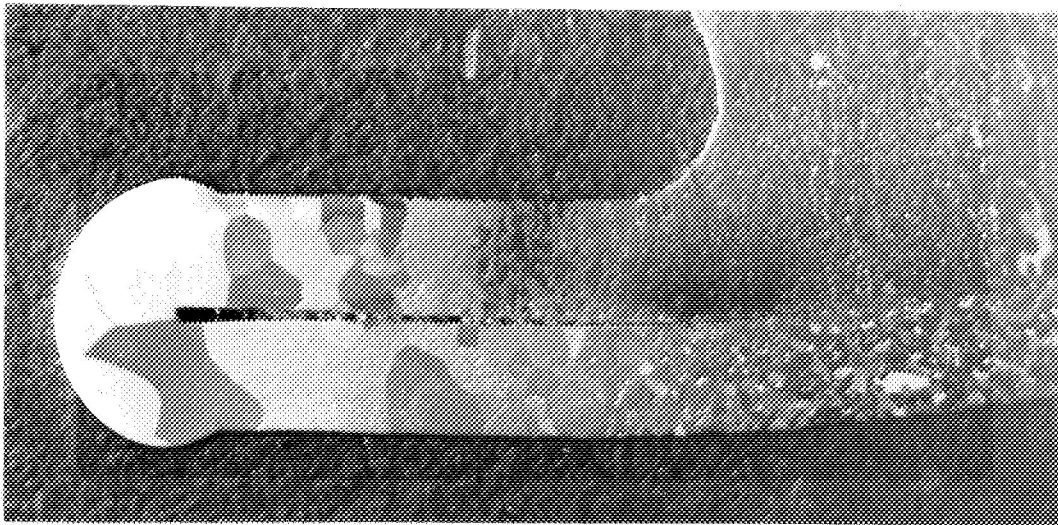
The Ta tube to header weld at the Hg outlet was also of excellent quality; no defects were detected metallographically, Figure 18. However, in the weld metal one grain comprised the entire wall thickness in some locations. The average hardness of the weld metal was 116 KHN with the weld softer on the surface (99 KHN) than below the surface (up to 129 KHN). This gradient is presumed to be due to the welding technique and not due to operational effects. The crown of this weld is exposed to the Hg side of the boiler. If system atmosphere contamination had occurred, the Hg exposed surface would have been harder than the core of the weld because Hg will not remove oxygen from the Ta as NaK does.

Figure 18 - Ta tube to header weld at Hg outlet.

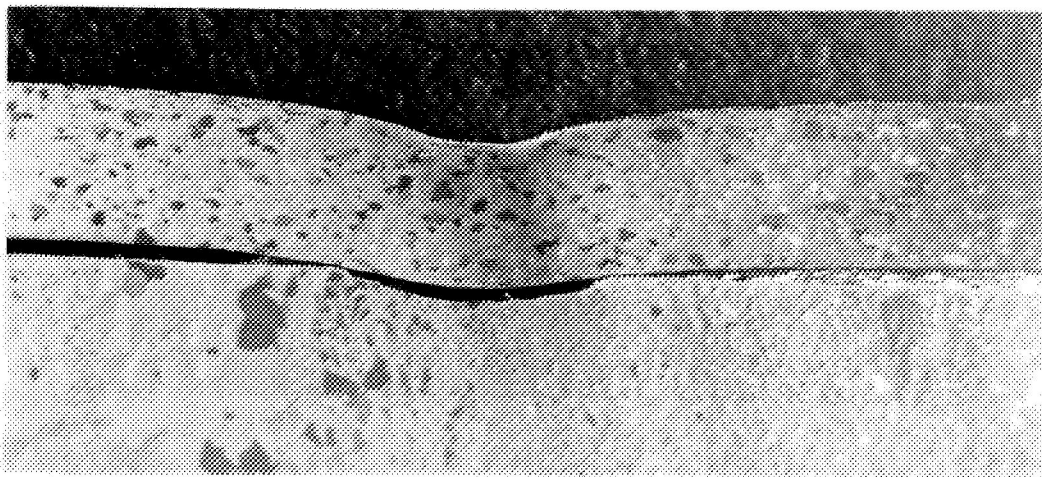
The area below the weld where the tube had been rolled into the header appeared satisfactory from a metallurgical standpoint, Figure 19. No evidence of incipient failure or other deleterious effects were observed. Although the rolled area appeared to provide some support of the tube by the header, there was not intimate contact along the entire rolled area between the tube and the header.

Figure 19 - Configuration of Ta tube where it was rolled into the Hg outlet header during boiler fabrication.

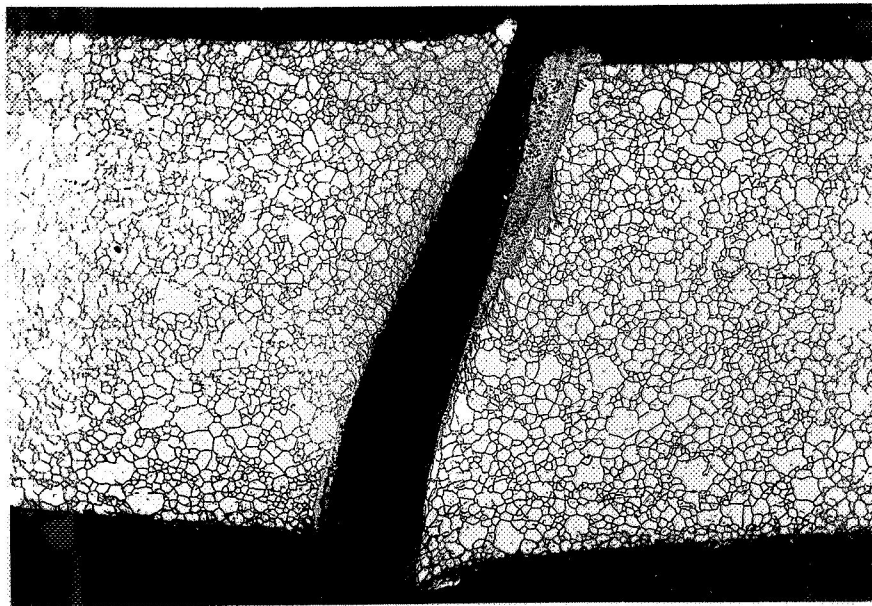
10. The static NaK tube failure was caused by excessive stress, inherent in this specific boiler design resulting from thermal excursions during system startup and shutdown, and retained stresses at steady state resulting in a failure phenomenon known as cyclic-rupture.

Another undesirable condition was cracking of the lowest 321SS static NaK containment tube which failed in the transition from round to oval cross section at the Hg inlet. This cracking was a cause of leakage between the static NaK and the PNL, but sectioning and post operational testing of the boiler was not continued to confirm that this was the only leakage path.

Stress analysis indicated that this tube had been subjected to a stress of 44 KSI and that failure could be attributed to cyclic thermal stressing which occurred during the heating and cooling of the boiler for system startups and shutdowns, (Reference (g)). A factor which caused additional stress in the failed tube but which was not included as part of the stress analysis was the longitudinal rubbing and galling of the bottom of the tantalum tube with the 321SS tube surrounding it. This was detected both visually and metallographically.

Figure 22 - Longitudinal cross-section through crack in 321SS static NaK tube near Hg inlet.

1. Design modifications should be made to reduce the stress level in the static NaK tube at the Hg inlet and in other areas where stress analysis or previous performance indicates cyclic overstress failure is probable.

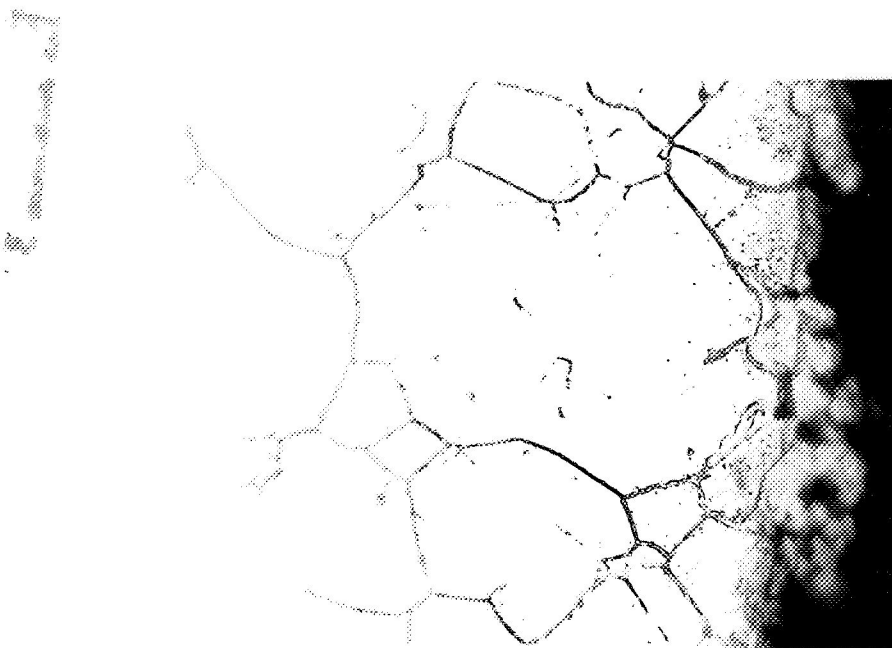
NaK corrosion was not detected on the I.D. of the shell material at either the inlet or outlet ends. However, mass transfer products up to 0.003" thick were present at the NaK outlet end, Figure 23. These products are the result of corrosion in the high temperature portion of the PCS-1 system. Presumably this corrosion occurred primarily in the gas-fired heater tubing used to simulate the reactor in the PCS-1 testing. Ultrasonic wall thickness determinations indicate the 316SS heater tubing wall has thinned an average of 0.0008 inches per 1000 hours of operation. Due to the non-isothermal nature of the system, the corrosion occurs at the highest temperature portion of the system and deposition occurs at the coldest areas of the system when due to the lower NaK temperature, the solubility of elements in solution decreases and precipitation occurs.

Figure 23 - Section through 316SS boiler shell at primary NaK outlet showing mass transfer deposition I.D. and absence of sigma phase in structure.

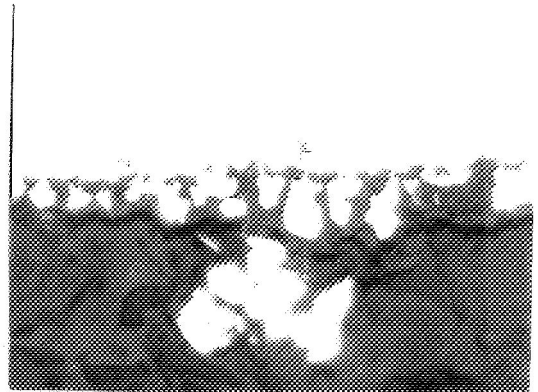
Figure 25 - Cross-section through 321SS static NaK containment tube at Hg inlet (left). I.D. exposed to static NaK; (right) O.D. exposed to flowing NaK. Unetched, 500X
